FUNDAMENTAL STUDY ON IMPROVEMENT OF WATER TIGHTNESS AND BOND STRENGTH AT INTERFACE OF SPRAYED MORTAR FOR REPAIRING OF TUNNEL LINING CONCRETE

Sohibjon ABILKASIMOV*¹, Akira HOSODA*², Yoshimi KOSE*³, Hiroki MIZUNO*⁴

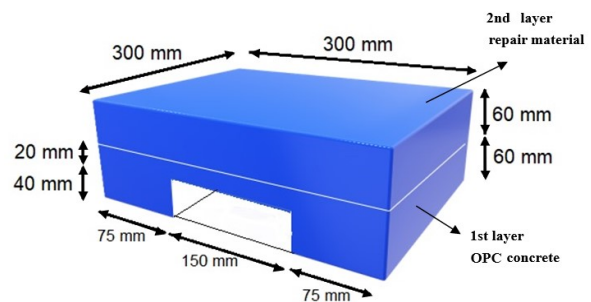
Fig.1 Design of rectangular specimen for bond strength test

In the current study, the authors tried various specimen shapes for conducting appropriate bond strength test for sprayed mortar and obtaining reliable data. Finally, the specimen with large indentation (150×300×40mm (length×width×height)) was provided for 60mm first concrete layer, as illustrated in Fig. 1. This indentation was necessary due to the restriction (length of the coring drill) of the coring machine for bond strength test. Fig.2 shows the situation of coring from the indented part of concrete layer.

The pull-out test was conducted using the specimens shown in Fig.1 and Fig.2.

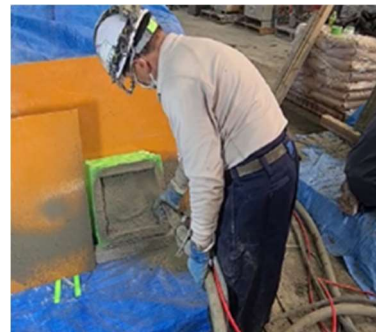
Fig.4 Casting of the second layer by shotcrete method

The second layer, made of the repairing mortar of 60mm thickness described in Table 3, was applied by shotcrete method as demonstrated in Fig.4.

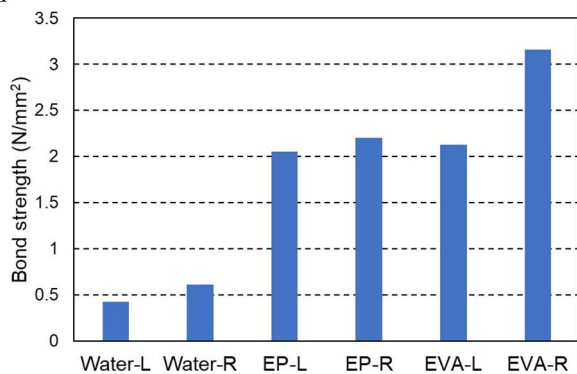
Fig.6 Results of bond strength test at 28 days

Fig.6 shows the results of the bond strength test at 28 days. 6 specimens showed variable bond strength results.

Two specimens in which no chemical agent was used for surface treatment at the interface (Water-L and Water-R) showed very low bond strength. Just wetting the surface of the original concrete may not be enough for this repairing mortar to obtain sufficient bond strength.

Two specimens in which Silicate-based Surface Penetrants (Ever Prolong) was used for surface treatment at the interface (EP-L and EP-R) showed much higher bond strength than Water-L and Water-R. The bond strength was higher than 2MPa and the effect of the mechanical roughness on the bond strength was not significant.

The specimens in which primer of EVA based adhesive was used (EVA-L and EVA-R) showed relatively high bond strength. EVA-R showed the highest bond strength of more than 3 MPa. The mechanical roughness of the surface at the interface had a remarkable effect on bond strength in these two specimens.

The specimen **Water-R** exhibited the weakest resistance against water pressure. In this specimen, water leakage was observed at 10 minutes after the water pressure reached 0.25 MPa. The specimen **Water-L** showed second lowest resistance, in which water leakage was observed at 25 minutes after the water pressure reached 0.5MPa. The two specimens which showed very low bond strength in Fig.6 showed low resistance against water pressure.

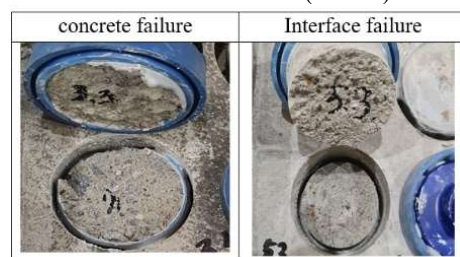
Fig.7 Failure patterns

After the bond strength test, failure mode was observed for each specimen. Here six specimens were subjected to testing, with two testing points designated for each specimen. The resultant values were derived by averaging the bond strength results obtained from these two testing points. The failure modes can be classified into three distinct categories. If the failure occurred at the interface (location C in Fig.5), it is interface failure. If the failure occurred at location B, it is concrete failure. If the failure occurred at location D, it is mortar failure. The failure at location A (the interface between the steel plate and mortar) must be avoided. In this study bond strength test at 28 days, we observed 2 kinds of failures. The interface failure was identified as the dominant mode of failure, constituting approximately 66.7% of the observed failures (Fig.7). The subsequent most frequent failure mode was concrete failure (33.3%).

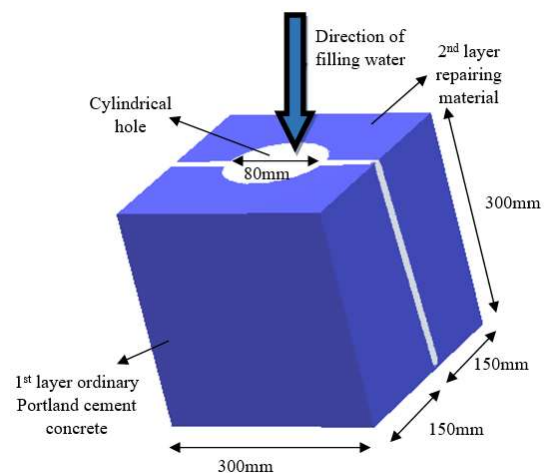
Fig.8 Shape of specimen for watertightness test

A special apparatus developed by the authors was employed to subject the specimens with construction joint to incremental water pressure ranging from 0.25 MPa to 2.0 MPa. Fig.8 shows the dimensions of the specimen with construction joint. For this investigation, 6 hollow cube specimens of 300 mm long with a construction joint and with an 80 mm diameter cylindrical hole were prepared.

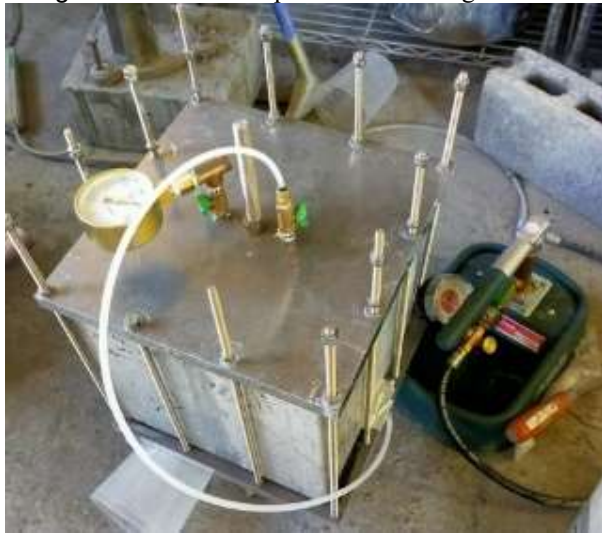
Fig.9 Water pressure test system

The watertightness test was conducted at around 60 days after the placement of the second layer. The set up of watertightness test is exhibited in Fig. 9.

The specimen with a construction joint and with a cylindrical hole in the center in vertical direction was sandwiched by two perforated stainless-steel plates, fixed securely using bar screws. Water leakage from the joint between the steel plate and the specimen was carefully avoided by deliberate sealing. Subsequently, water was introduced into the cylindrical hole of the specimen through a specified injection orifice, and the application of water pressure was carried out manually, utilizing a pump-driven apparatus for pressurization.

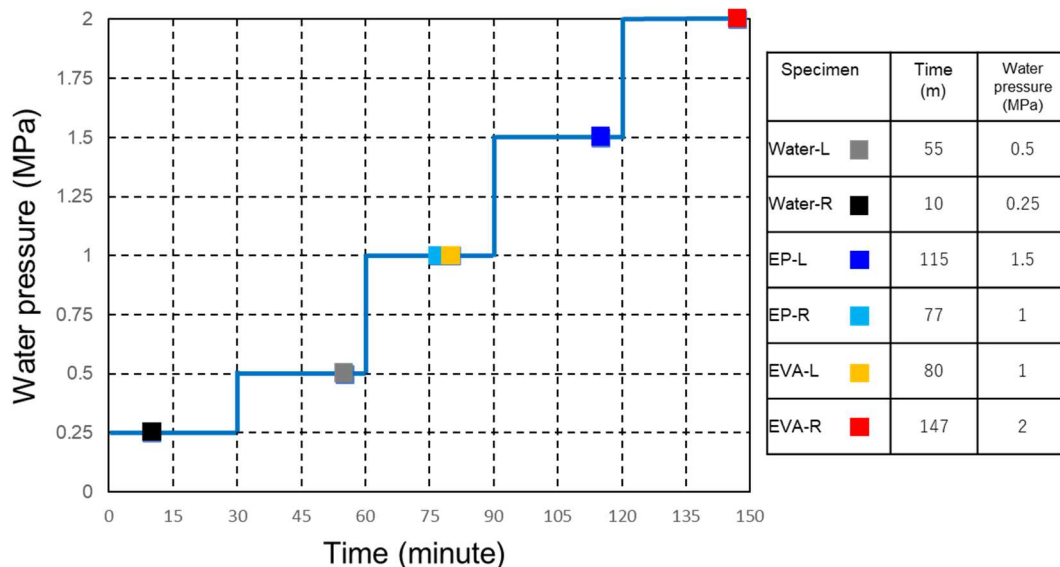
Fig. 10 Water pressure change over time and start point of water leakage

Fig. 10 shows the change of water pressure over time and the colored square dots in the figure show the starting points of water leakage of the specimens. 6 specimens showed different watertightness and water leakage was observed in different time in each specimen.

Two specimens in which silicate-based surface penetrants (Ever Prolong) was used for surface treatment at the interface (**EP-L** and **EP-R**) showed much higher watertightness than **Water-L** and **Water-R**. Especially, **EP-L** showed relatively high resistance, in which water leakage was observed at 25 minutes after the water pressure reached 1.5MPa. In **EP-R**, water leakage was

observed at 17 minutes after the water pressure reached 1.0MPa.

The specimens in which primer of EVA based adhesive was used (**EVA-L** and **EVA-R**) also showed relatively high-water tightness. Especially, **EVA-R** showed the best resistance, in which water leakage was observed at 27 minutes after the water pressure reached 2.0MPa. In **EVA-L**, water leakage was observed at 20 minutes after the water pressure reached 1.0MPa.

Fig. 10 and 11 show the experimental results of watertightness test.

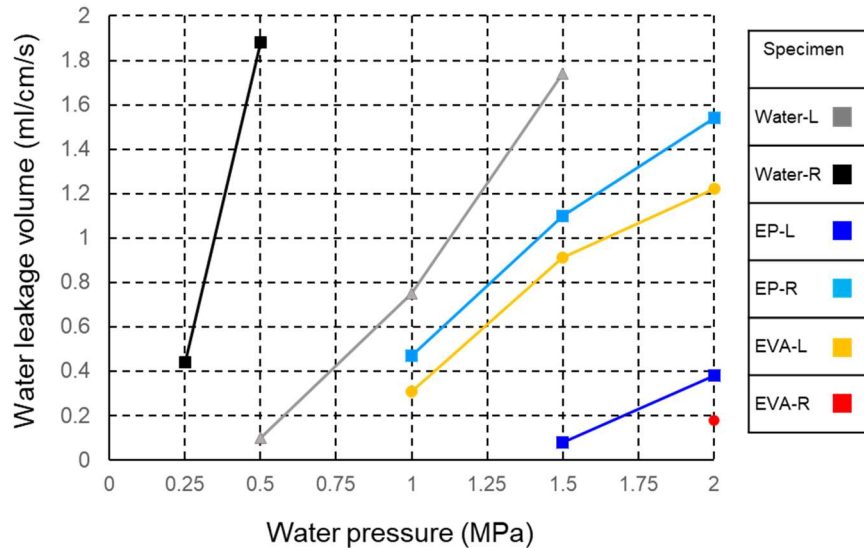
Fig. 11 Results of measurement of water leakage

Fig.11 shows the results of measurement of water leakage volume over time in each specimen.

The specimen **Water-R** whose resistance of watertightness was the lowest showed water leakage of 0.44 ml/cm/s at water pressure of 0.25 MPa, which increased to 1.88 ml/cm/s at 0.5 MPa, and then finally this specimen was broken due to water pressure.

The specimen **Water-L** started to show water leakage of 0.1 ml/cm/s at water pressure of 0.5 MPa, which increased to 1.74 ml/cm/s at 1.5 MPa, and then finally this specimen was also broken due to water pressure.

The specimens in which primer of EVA based adhesive was used (**EVA-L** and **EVA-R**) showed relatively high-water tightness. Especially, **EVA-R** showed the best performance, in which water leakage was only 0.18ml/cm/s at 2.0MPa. **EVA-L**, in which the surface of the interface was less roughened, showed lower resistance than **EVA-R**. **EVA-L** started to show water leakage of 0.31 ml/cm/s at water pressure of 1.0 MPa, which increased to 1.22 ml/cm/s at 2.0 MPa. The specimen was not broken at 2.0 MPa.

The specimens in which silicate-based surface penetrants (Ever Prolong) was used for surface treatment at the interface (**EP-L** and **EP-R**) also showed relatively high-water tightness. Especially, **EP-L**, in which the surface of the interface was less roughened showed the

second-best performance. EP-L showed water leakage of 0.08ml/cm/s at 1.5 MPa, which increased to 0.38 ml/cm/s at water pressure of 2.0 MPa. EP-R started to show water leakage of 0.47 ml/cm/s at water pressure of 1.0 MPa, which increased to 1.54 ml/cm/s at 2.0 MPa. This specimen was not broken at 2.0 MPa.

precise records were made for the timing of leakage and the corresponding water pressure. Additionally, the quantity of water absorbed by the paper attached to the leakage point was measured, from which the water leakage amount per unit length of the joint (ml/cm/s) was obtained.

- (1) The weight of dry paper was measured on a scale before attaching the paper to the joint.
- (2) All the papers were collected at the end of each 30 minutes under a predetermined water pressure.
- (3) The total weight of the papers was measured using the scale.
- (4) To determine the amount of water leakage, the weight of the dry paper was subtracted from the total weight.
