- Technical Paper -

SEISMIC BEHAVIOR EVALUATION OF A RC RIGID-FRAME ARCH BRIDGE SUBJECTED TO DIFFERENT TYPES OF SEISMIC WAVE

Zhongqi SHI^{*1}, Kenji KOSA^{*2}, Jiandong ZHANG^{*3} and Hideki SHIMIZU^{*4}

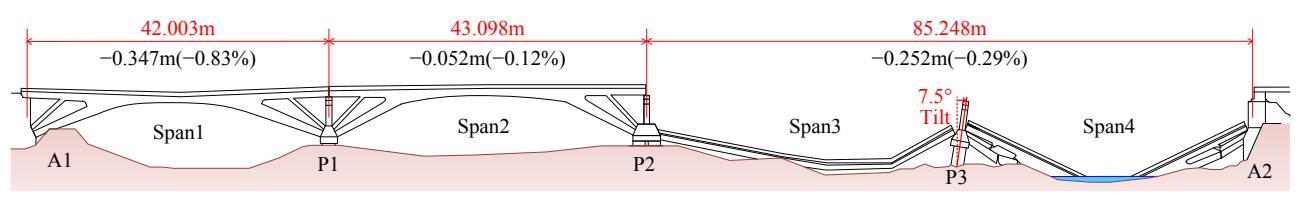
Fig. 1 Elevation view of Xiaoyudong Bridge after the earthquake (view from upstream)

The Wenchuan EQ occurred in Sichuan Province, China, on May 12th, 2008. The magnitude was 8.0 by CEA and 7.9 by USGS^[1]. Reports have been published saying that nearly 1600 bridges suffered extensive damage. Authors conducted detailed field surveys on Xiaoyudong Bridge, as shown in Fig. 1, which crossed Baishui River in Xiaoyudong Town on Peng-Bai Road. This bridge is a 189m long, 13.6m wide, 4 spans, RC rigid-frame arch bridge that was built in 1998. Rigid-frame arch bridge is a composite structural type of arch bridge and inclined rigid-frame bridge, and a high-order hyperstatic structure with horizontal thrust. It has been abundantly constructed in China since 1980s. By a statistical investigation, the accumulative total length of this type of bridge exceeds 15,000 km.

Detailed information of Xiaoyudong Bridge has been summarized in Reference [2] and [3] for both bridge structure and damage condition. As shown in Fig. 1, totally 4 spans were arranged. Abutments, piers and spans are numbered from left. Span 1, 4 and Span 2, 3 has the length of 42.35m and 43.15m respectively. Details of Span 4, which is to be modeled in following analyses, are shown in Fig. 2. Arch leg (Point A) and inclined leg (B) has 21° and 40° slope respectively. Arch legs from each side and girder in mid-span form

the arch frame. It composes one single rigid-frame with inclined legs, and girder at ends. A span consists of five rigid-frames connected by crossing beam, arch slab, and extending slab. Besides, Fig. 1 also introduced the damage condition generally. A1 suffered collision with the deck. Span 1, 2 survived to stand still, but arch legs of Span 1 collided with revetment and failed due to shear. Span 3, 4 fell into the river entirely. P3 tilted about 7.5° toward A2. A2 suffered notable shear failure, which was caused by the collision with deck before its collapse. Besides, greatest span length change occurred to Span 1 about -0.347m (-0.83%), while the shortening of Span 2 reached only -0.052m (-0.12%), and Span 3, 4 were slightly shortened by 0.252m (-0.29%) totally.

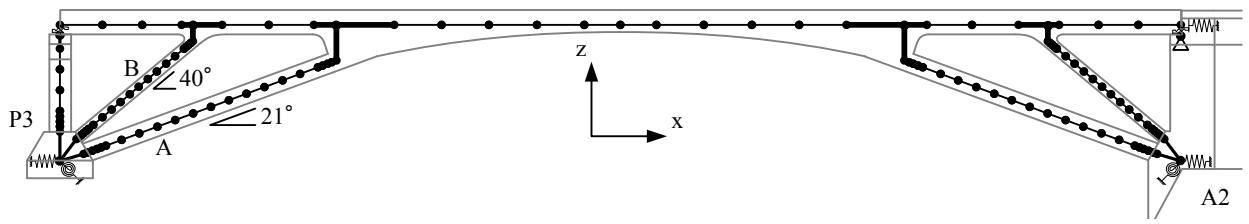
Fig. 2 Structure and analytical model of Span 4

Frame model is made for Span 4, in Fig. 2. On the transversal direction, noticing five arch frames were arranged, we select one single frame to establish the 2-D model. Due to greater sectional area and rebar amount, rigid element is set to footings, beam on the top of pier and joints between legs and girder. Besides, horizontal and rotational springs under P3 and A2, supporting and friction spring upon P3, supporting, friction and collision springs upon A2 are assumed based on former studies^[5]. Additionally, tri-linear M- Φ relationships are calculated by the axial forces under dead load based on the Japanese specifications^[6]. Damping coefficient of 2% and 20% is respectively used to superstructure and base springs.

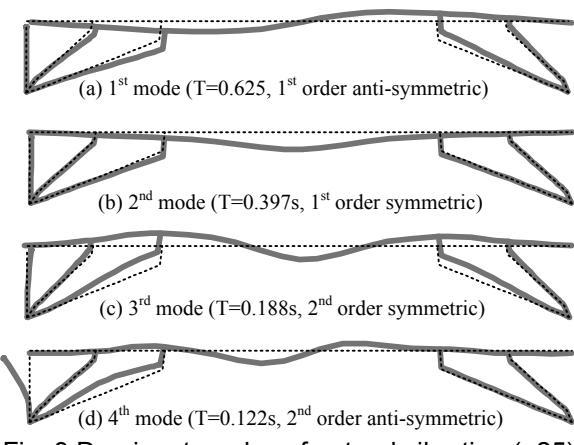
Fig. 3 Dominant modes of natural vibration (×25)

Generally, the 1st, 4th modes and the 2nd, 3rd modes provide greatest mid-span displacement in horizontal and vertical direction respectively. Thus, their vibration modes are shown in Fig. 3. The 1st mode (0.625s) vibrates as 1st-order anti-symmetric. The vibration of the 2nd mode (0.397s) is controlled by the up-down movement at mid-span. The 3rd and 4th mode deforms in the 2nd order symmetric and anti-symmetric shape respectively.

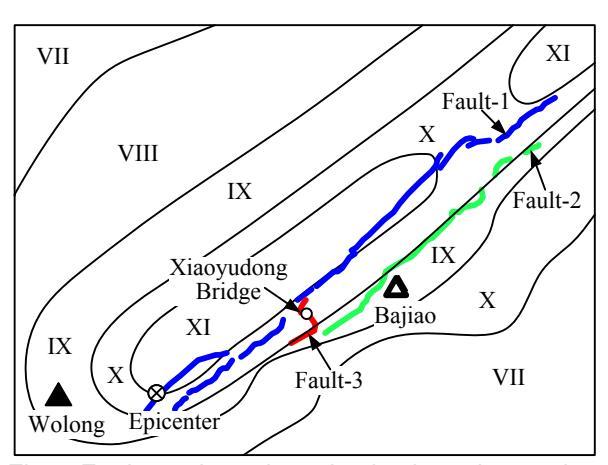
Fig. 4 Faults and nearby seismic observing stations

Two main surface faults have been defined after Wenchuan EQ, Fault-1 and Fault-2 in Fig. 4. These two surface faults roughly divided the zones of intensities geographically. Also important is another fault named Xiaoyudong Fault (Fault-3), which roughly connected the main two. Our object bridge located between Fault-1 and Fault-2, and very close to Fault-3. Based on

the investigation^[1] on nearby surface faults, Fault-3 probably extended along the left dyke of Baishui River and crossed the road at 10m and 50m behind A1, which is considered to be the main reason for the collisions occurred between A1 and the deck, and between the revetment and arch legs. However, on the other side, there was no obvious trace of surface fault having been found at the right dyke (A2 side).

Further, the locations of two available seismic observing stations, Bajiao and Wolong, are illustrated in Fig. 4. Bajiao wave is used as standard case for its shortest distance from the bridge for Case-1, while Wolong wave and Takatori wave (in 1995 Hanshin EQ) are used for Case-2 and Case-3 respectively for parameter studies. Being a special RC arch bridge, the bridge is significantly affected by U-D component of wave. Thus, both the U-D and E-W (since the bridge is roughly along E-W direction) components are used. Response acceleration spectra are shown in Fig. 5.

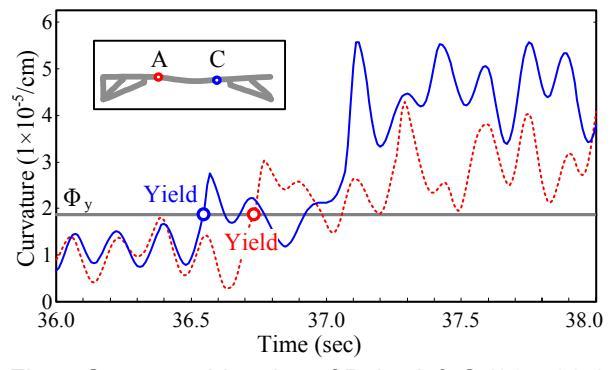
Fig. 7 Curvature histories of Point A & C (36s~38s)

The curvature history is shown in Fig. 7 for Point A and C. As the vibration becoming strong, Point C reaches the yield curvature at 36.55s firstly, followed by Point A at 36.74s. Their non-linear response can be confirmed in Fig. 8. Then, Point E, the right bottom of inclined leg, yields due to extensive decrease of axial

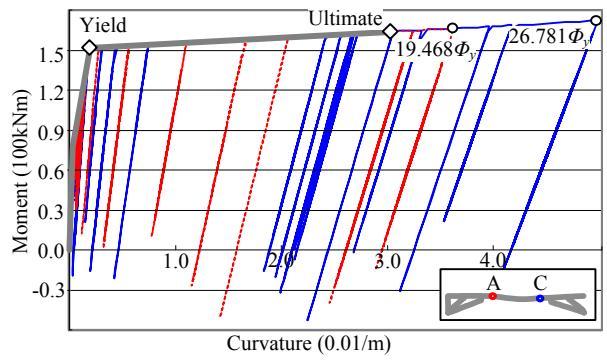
Fig. 8 M-Φ histories of Point A & C

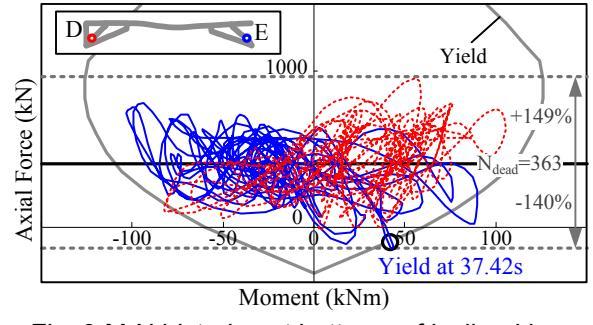
Fig. 9 M-N histories at bottoms of inclined legs

force at 37.42s (in Fig. 9). Besides, as shown in Fig. 9 as well, the axial force in the inclined legs varies considerably from -140% to +149%. This is a phenomenon with considerable importance that affects the failure of inclined legs. However, as being a horizontal member, the girder is not influenced by the

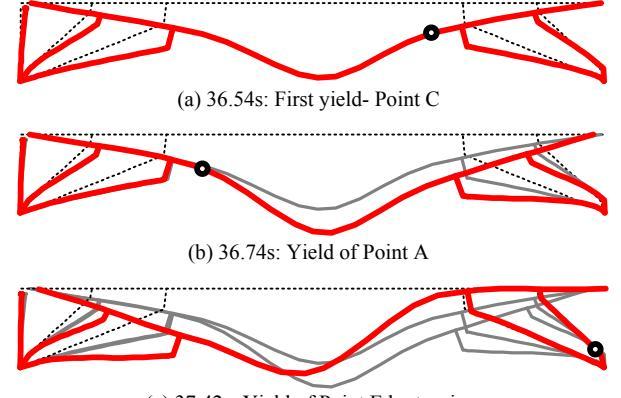
(c) 37.42s: Yield of Point E by tension

The development of deformation shape for these first three yields is illustrated in Fig. 10. Compared with the modes shown in Fig. 3, the dominant modes can be roughly judged. The deformation shape in (a) and (c) are able to be confirmed by the 2nd and 1st mode respectively, while (b) may be considered as that, based on the shape of the 2nd mode, rotation of both sides bring in the effect of the 1st mode. Thus, the 1st and 2nd modes mainly control the vibration.

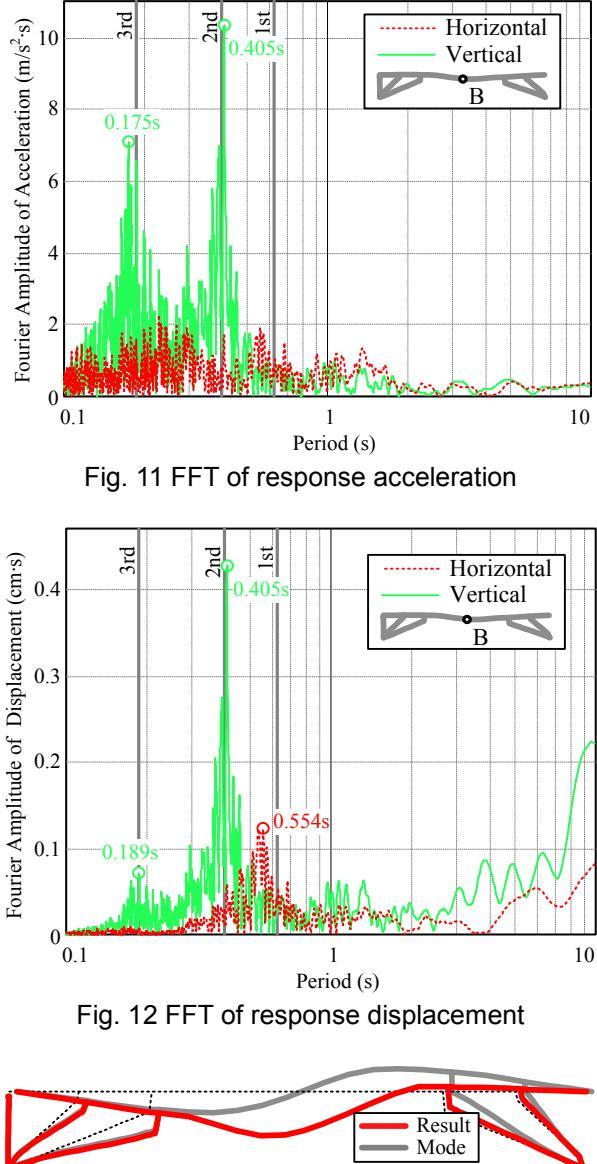
(a) 42.08s: Girder Max Horizontal Disp (×25) & 1st mode (×50)

Fig. 13 Deformation of analytical result and mode

This result is confirmed by the comparisons shown in Fig. 13. The 1st mode and the deformation, when girder reaches maximum horizontal displacement, are shown in Fig. 13 (a), from which we can see clockwise rotations at both sides made the deformation similar to the 1st mode. (b) illustrates the 2nd mode and the deformation when Point B has maximum vertical displacement. Although the failure of mid-span caused the notable drop at middle, both 2 comparisons show similar deformation shape, and good coincidence between the dominant modes and the actual vibrations.

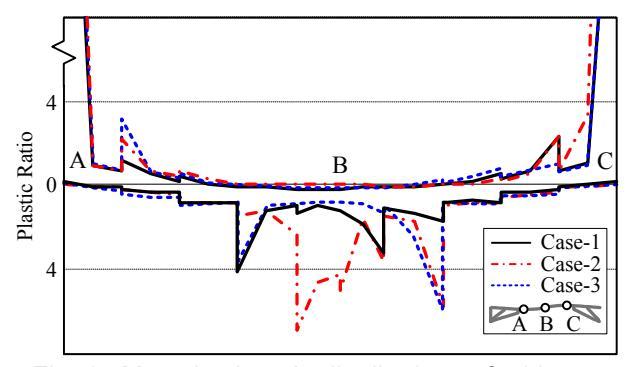
Fig. 14 Max plastic ratio distributions of mid-span

By Eq. 1, max plastic ratio is calculated and compared in Fig. 14. We can see that the max plastic ratio distributions of mid-span are with similar shapes:

μ_{max} is relatively great near Point A, B and C. It indicates that the general damage conditions of girder did not obviously distinguish from case to case. Thus, conclusion can be drawn that Point A and C are the weakest points of this bridge, while Point B may suffer notable damage too. Moreover, we can find that Point A, B and C suffered most noticeable failure in Case-2, as the comparison summarized in Fig. 15. The max plastic ratio at the bottoms of legs (where were also found to be weak points, mentioned in 4.1) are shown in Fig. 15 as well. Phenomena are found that for the girder, Case-2 (Wolong wave) shows the most destructive influence, followed by Case-3 (Takatori wave). But for the bottoms of legs, Case-3 affected the bridge most severely. Besides, Case-1 was weakest to destroy the bridge for both the girder and the legs judged by μ_{max} .

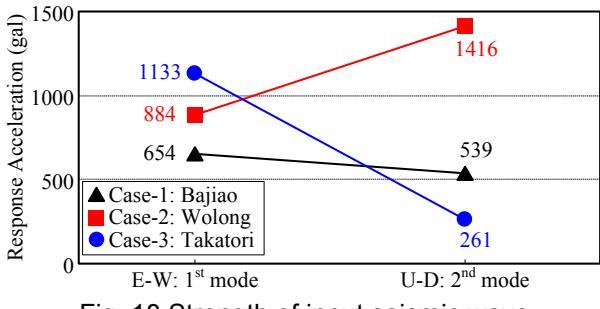
Fig. 18 Strength of input seismic wave

To summarize the influence from seismic waves, the properties of wave are summarized for 2 directions separately (in Fig. 18) according to Fig. 5. Based on the previous explanation of modes effect, the accelerations of the 1st and 2nd modes are used as representations for the horizontal and vertical vibration respectively. From Fig. 18, we can see that Case-1

(Bajiao wave) has similar strengths for both directions (654gal and 539gal). Case-2 (Wolong wave) gives extremely strong U-D wave (1416gal), while it is also not weak in E-W direction (884gal). However, Case-3 (Takatori wave) is only strong in E-W direction (1133gal), but weak in U-D (261gal).
